Corrosion and Deposits in Water-Cooled Generator Stator Windings: Part 4: Operating Experience with Flow Restrictions in Stator Cooling Water Systems

Matthias Svoboda and Thomas Bauer

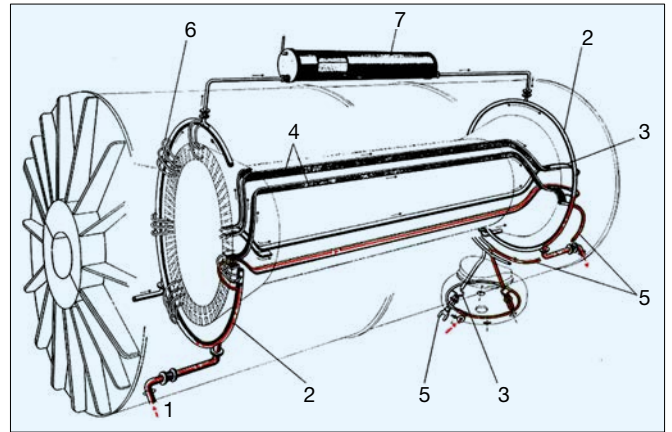
Once the issue was identified, analysis of stator bar outlet temperatures showed that the plugged bars were distributed in a non-random pattern. This pattern was consistent with the fact that when the stator is drained at the inlet and outlet manifolds without proper blowdown, only about one-third of bars actually drain; the other bars remain filled with water as their end windings and the connecting insulating hoses are bent upwards on both sides (Figure 1).

Figure 1:
Schematic of a generator stator. Only four bars are shown for clarity. Like the bars shown, approximately one-third of the bars will drain by gravity alone; the rest of the bars will remain filled as their bar ends or insulating hoses point upward and prevent draining.

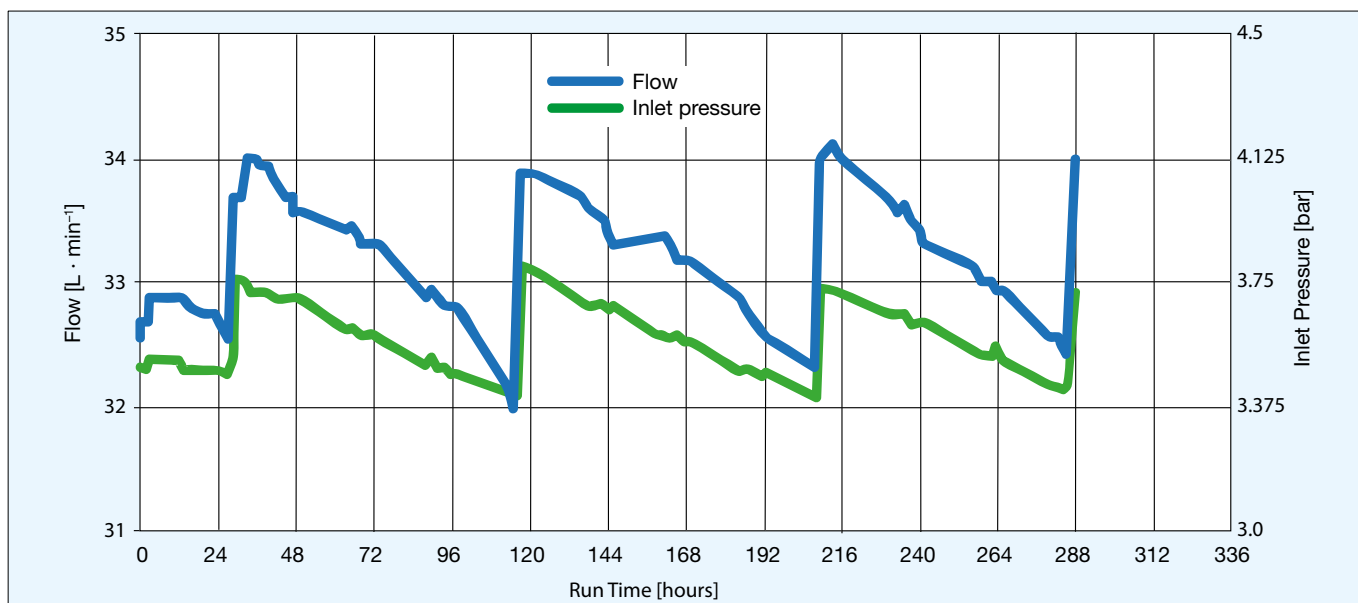
Figure 3:

Flow and inlet pressure at the stator winding over time in plant H. Outlet pressure is atmospheric and approximately constant. Every four days the main system pressure control valve opens and increases flow to the stator. The reason for this is that the pressure control valve is tied to the generator casing hydrogen pressure and reacts to the regular manual hydrogen top-ups to the generator.

The other difference is that during the cleaning on Unit One, a fluctuation in stator cooling water flow was observed (Figure 3). The frequency of these fluctuations coincided with plant operations personnel replenishing generator casing hydrogen gas approximately every four days.

The flow regulating valve of the SCWS is partly controlled by generator gas pressure to ensure that stator inlet pressure does not exceed gas pressure. This is a safeguard so that in the case of leaks no water can enter the generator casing. When gas is replenished, casing pressure increases and allows the flow regulating valve to open more. This results in a relatively abrupt increase in cooling water flow, and thus an increase in water velocity in the hollow conductors.

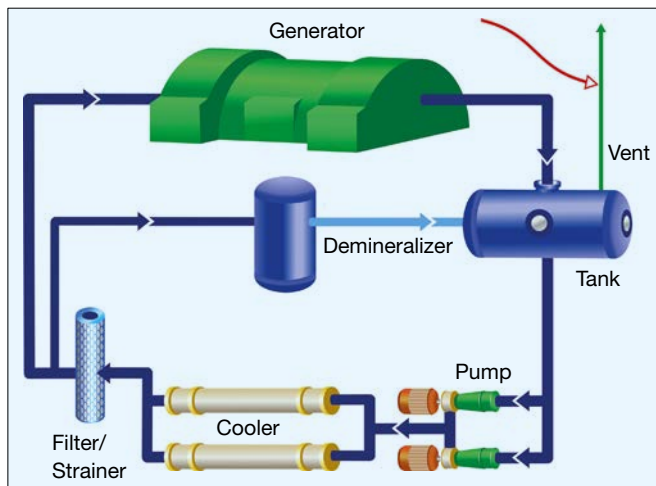
- The unit's hydrogen drier required regular flushing of its standby cartridge with air. This air was then routed directly into the stator tank vent pipe (Figure 4). As the stator vent pipe is an open connection between the stator expansion tank and the atmosphere, significant amounts of this purge air would reach the stator tank gas space. The CO₂ contained in this air would upset the pH in the cooling water temporarily.

Figure 4:
Simplified stator cooling water system. The location where the hydrogen drier flushing line is tied into the stator expansion tank vent line is marked with a red arrow.

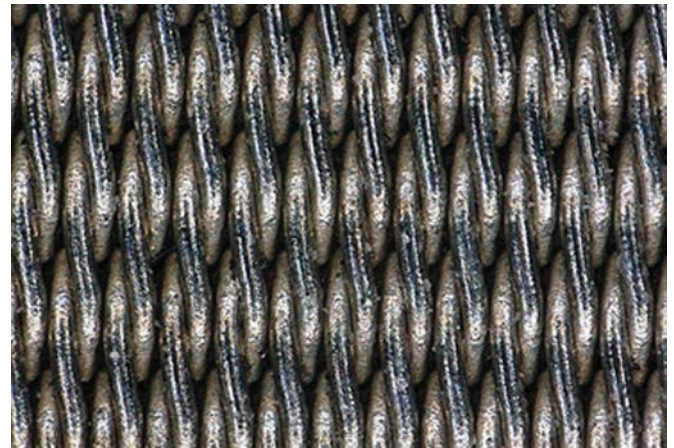
Finally, the strainer itself had such a small open cross-section that flow velocities and turbulences were likely excessive. Strainer size was specified by mesh size, which does not directly correlate with the total open cross-section

available for the water flow. This cross-section varies both with wire strength and the weave used. There are indications that the original system was designed for a plain weave, while the strainers in use had a Dutch weave, which has a smaller open cross-section per m² at a given selectivity (Figure 5).

Figure 5:
Dutch weave strainer mesh resulting in smaller open cross-section than a plain weave mesh as was originally specified. This results in higher flow velocities through the strainer mesh.

The solution was to install strainers with a larger open cross-section (a plain weave strainer basket was used). At that opportunity, the single strainer vessel was replaced by parallel dual strainers that can be switched over during operation, allowing online strainer swaps. After more than six months of operation, this was not yet necessary.

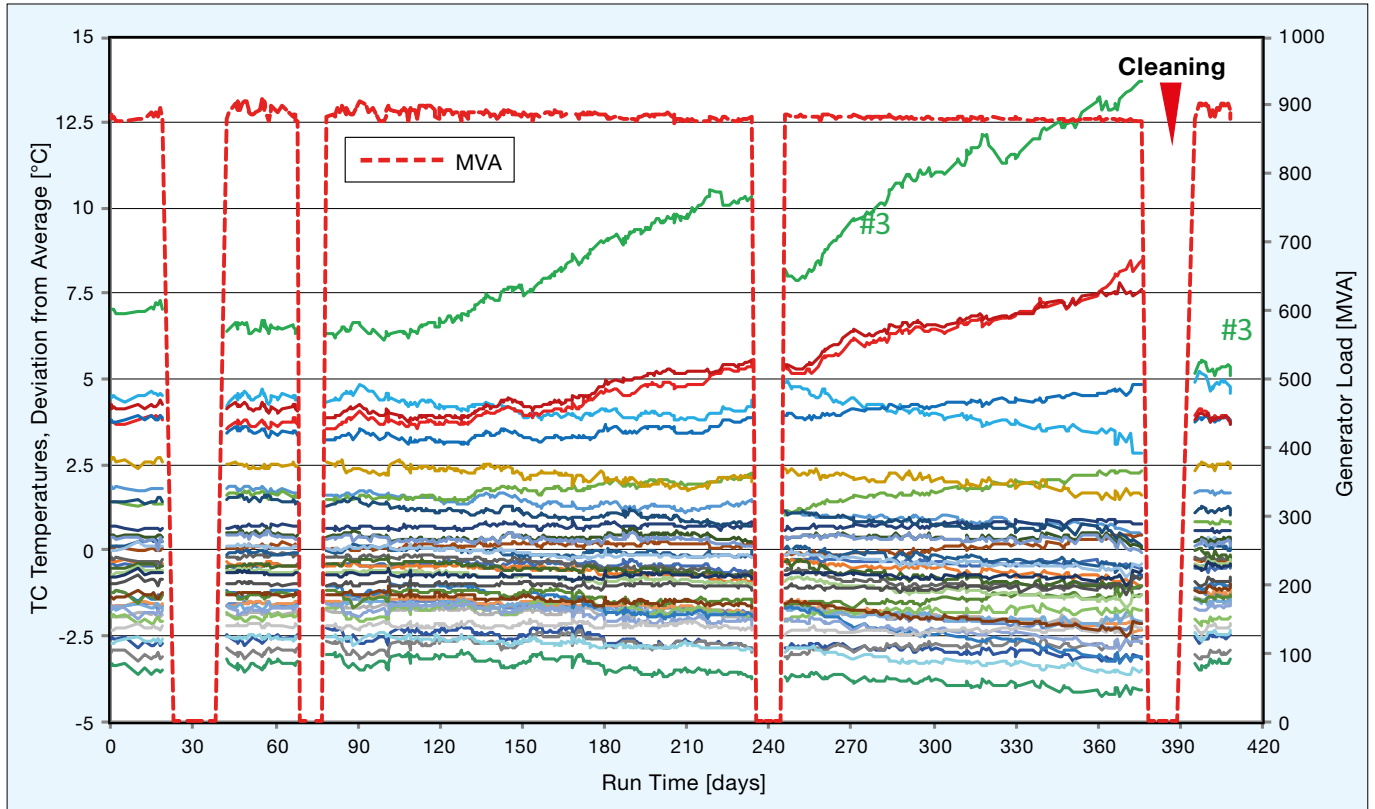
After six years of increasingly frequent strainer and filter swaps, stator bar temperatures in Unit Two started rising to a point where it became evident that the winding was starting to plug up (Figure 6). A chemical cleaning was car-

Figure 6: Temperatures of thermocouple elements at the outlet insulating hoses in plant OG. Each insulating hose combines the outflow from a pair of separate top and bottom bars. Shown is their deviation from average normalized to a standard load of 880 MVA. The dashed red line (MVA) represents the actual generator load; the dips indicate periods where the plant was shut down. It is evident that not all bars are plugging up equally. Some of the hottest pairs may have several hollow conductors completely plugged. This was also reflected in the results from ultrasonic flow testing.

ried out. This was successful, but a few bars were still left with slightly increased temperatures. Ultrasonic flow tests confirmed the results.

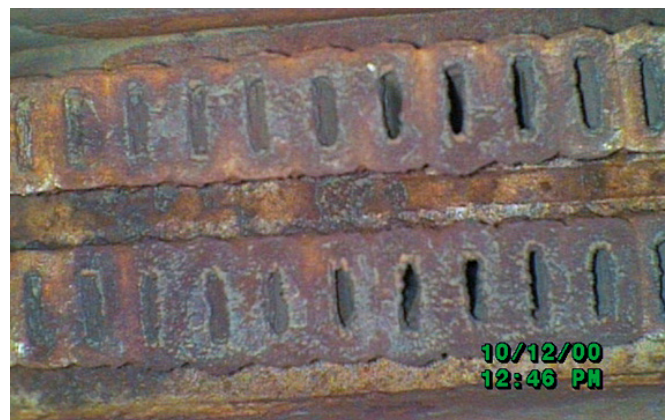
Figure 7: Stator bar inlet water box with copper oxide deposits as found during visual inspections at plant S. The areas around the hollow conductor inlets are particularly affected, as they lie in an area of high turbulence and flow velocities.

While ultrasonic flow tests did not return any results out of the norm, a failed Hipot test indicated problems. Visual inspections confirmed this suspicion and found partial plugging in the hollow conductor inlets (Figure 7). The stator bar insulating hoses had deposits that were analysed as consisting almost completely of metallic copper.

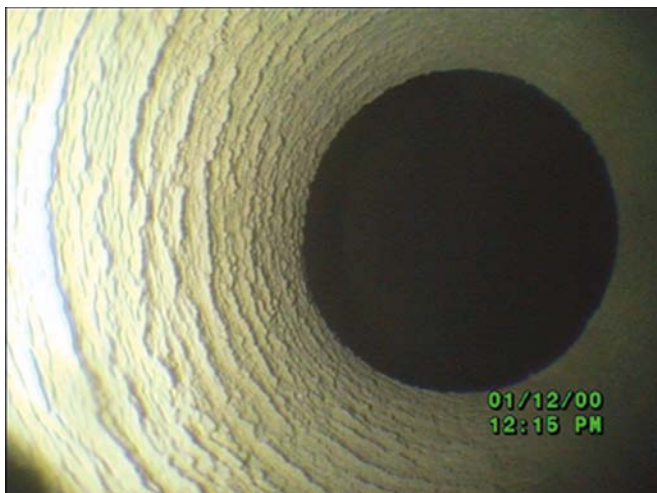
However, visual inspections on the individual cooling water hoses revealed deposits on their insides (Figure 8). They were cleaned with bottle brushes and about half a kilogram of oxides was removed from the hoses. These deposits consisted mostly of Cu_2O . The chemical cleaning

Figure 8: Heavy copper oxide deposits inside an insulating hose supplying water to a stator bar. These deposits were analysed as being mostly Cu_2O .

on the whole system yielded the highest amount of copper oxides so far encountered by the experienced team. More than 12 kg of copper from oxides were removed.

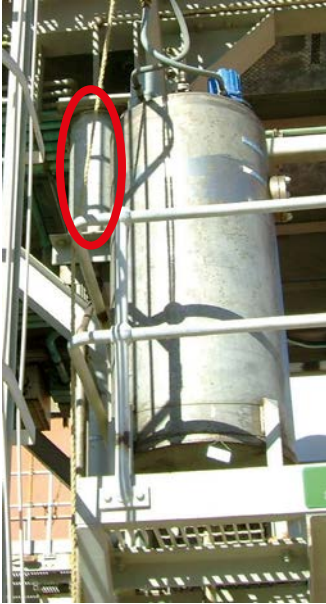
In the case of plant SD, hydrogen leakage into the system was large enough to fill or almost fill the detrain volume. The gas volume that subsequently vented was too large in relation to pipe diameter, so that it displaced the water column vertically until the pipe discharged all of its approximately 20 L of cooling water through the roof vent. This process repeated every four hours, which led to over a hundred liters of water being lost each day.

Figure 9:
Head tank and expansion vessel for the stator water detrainment tank vent line. The expansion vessel is the small vessel to the left of the larger head tank. It prevents the standing water in the line from escaping through the vent if large amounts of gas are released at once.

The solution was to install an expansion vessel in the vent pipe, as has already been installed in other plants of similar design (Figure 9).

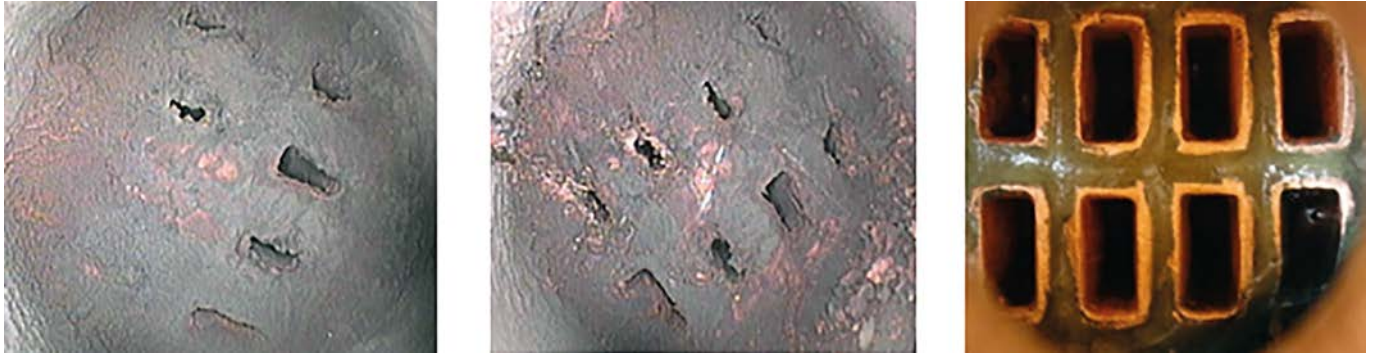
Figure 11:
Stator bar inlet water box as found (left), after mechanical treatment with a metal rod to open flow passages (middle), and finally after targeted chemical cleaning (right) [10].

Access to the face plate with the hollow conductor inlets was open and direct, so the tool of choice for the initial mechanical cleaning was a simple wire, as using a drill was found to be too damage-prone. The hardness of the well-aged deposits made this difficult, however, and only an application of a suitable cleaning solution softened up the deposits enough that a channel could be poked through.

Once flow was established, the chemical cleaning was able to remove all copper oxides from the bars, leaving them in pristine condition (Figure 11).
