Flow Restrictions in Water-Cooled Generator Stator Coils: Prevention, Diagnosis and Removal

Part 4: Chemical Cleaning of Water-Cooled Generator Stator Coils by the Cuproplex[®] Method

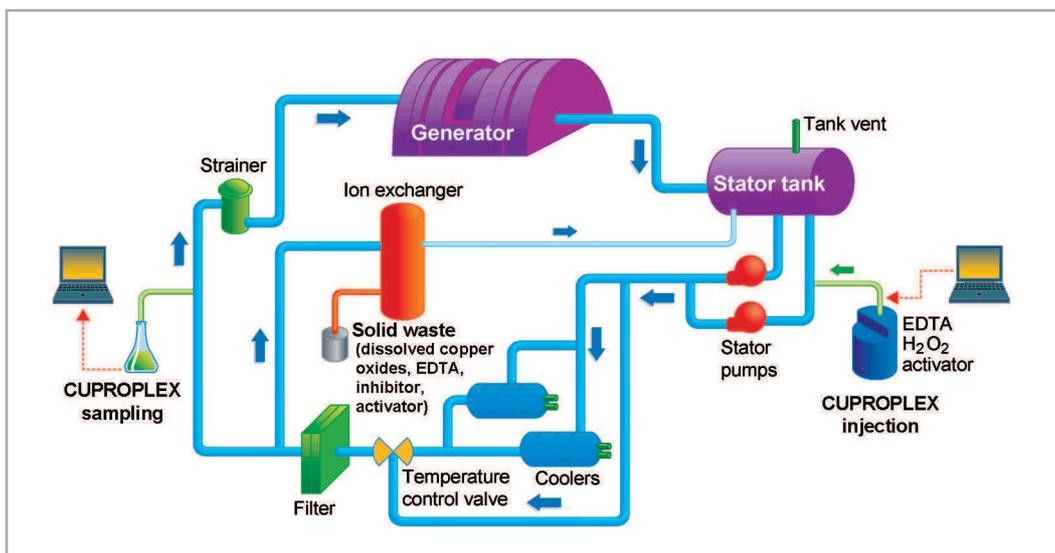
Figure 1:
Application plan for the
Cuproplex process.

Figures 1 and 2 give a process overview and show a typical set-up.

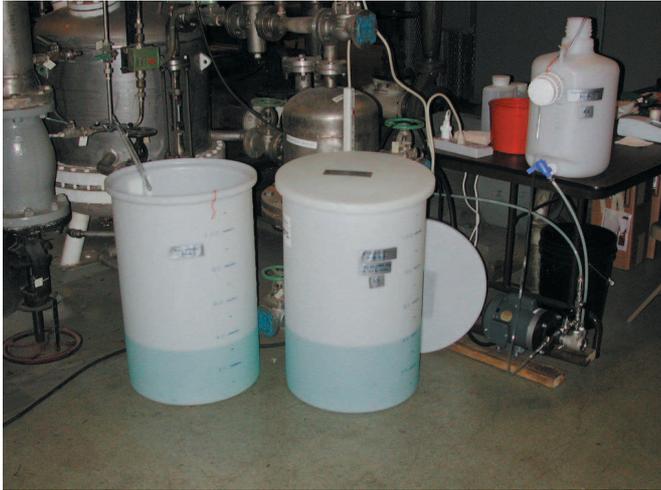
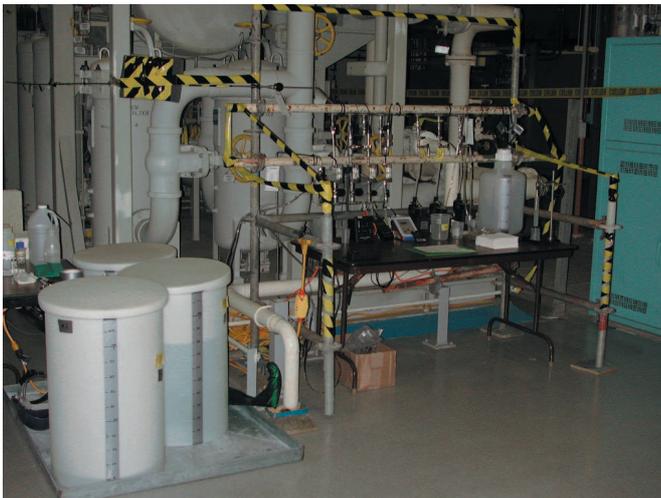
Figure 2: Typical set-up for off-line (top) and for on-line cleaning (bottom).

Cuproplex Off-Line is performed by injecting the chemicals into the running pure-water system. The chemicals are applied in dilute form, sequentially over several cycles. The application of the chemicals is modified according to the response of the system to the chemical changes. The end of cleaning is usually not indicated before the reaction yield decreases, that is, when little or no additional oxides are dissolved as new chemicals are added.

Cuproplex On-Line employs the continuous injection of chemicals at a sufficiently dilute concentration to keep

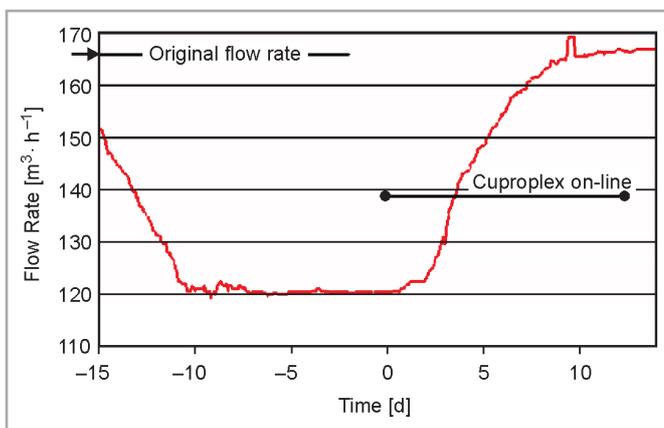
Figure 3: Plant S: Improvement in cooling water flow by chemical cleaning. Date zero indicated the start of on-line cleaning. The data before show the deterioration of cooling water flow as the result of continuous oxygen injection. Cooling was fully restored by Cuproplex on-line cleaning. The generator was on-line all the time.

Figure 3 displays the results of the on-line cleaning of a generator with a design high-oxygen chemistry. Due to insufficient feed of air into the system, the water had in fact a low-oxygen content for many years. At the point when

large amounts of air entered the system, the stator water flow started to decrease substantially (Figure 3). In consequence, the load of this 1160 MW nuclear power plant had to be reduced in peak demand season. On-line cleaning brought back the plant to full cooling capacity, permitting full power operation within a few days. As a special feature, this generator had active clip-to-strand leaks [5]. They did not increase with cleaning.

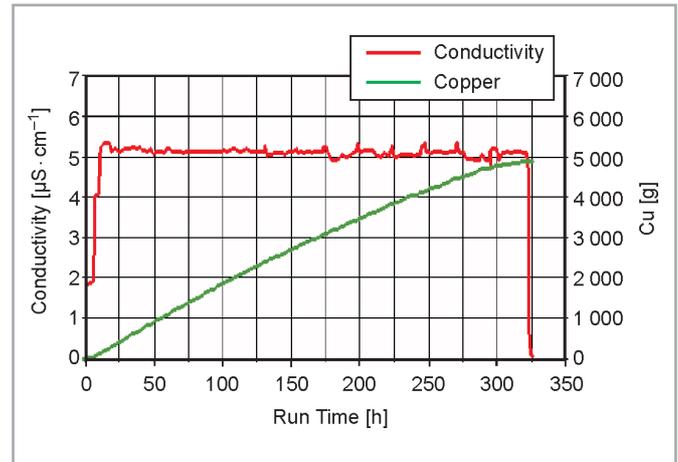
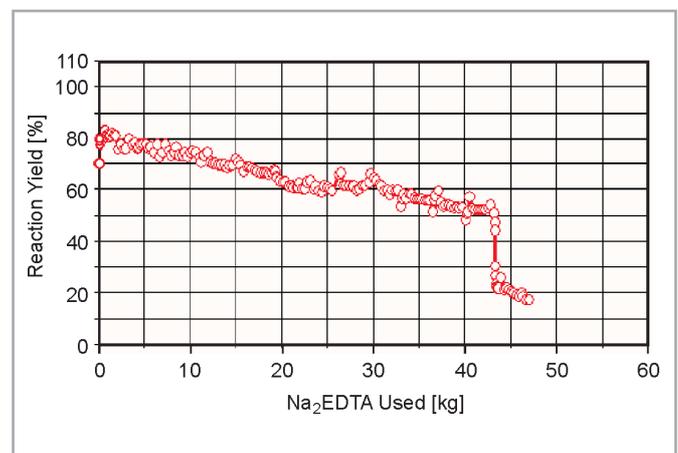
Figure 4: Plant P6: Conductivity, copper removal (top), and process reaction yield (bottom) during the on-line cleaning.

Figure 4 shows that the conductivity could be kept stable at the nominal value throughout the cleaning. Higher conductivity would have tripped the generator. It can also be seen that the reaction yield decreased to low levels towards the end of the cleaning, indicating that further clean-

ing would remove only a small (but possibly still important) quantity of oxides.

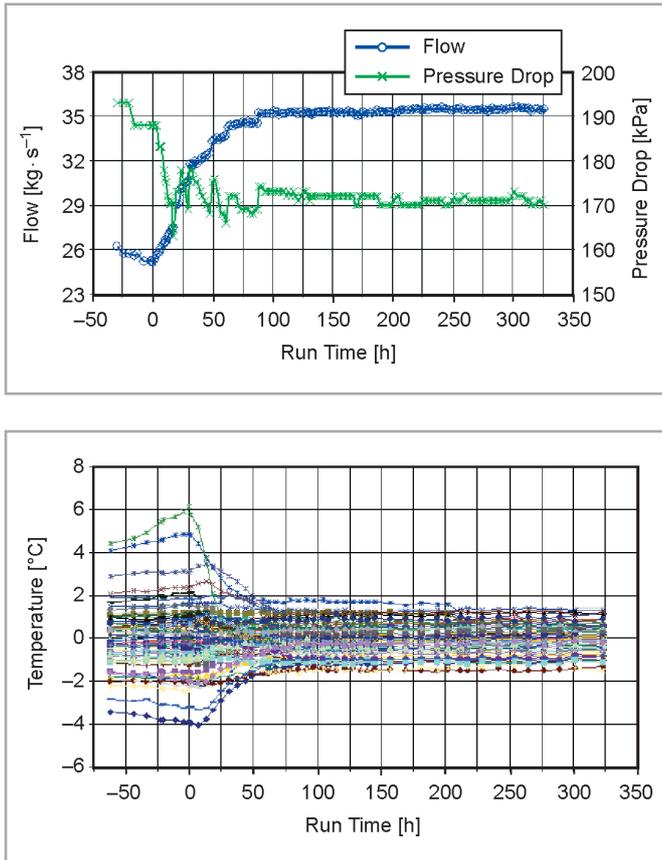
Figure 5: Plant P6: Improvement in stator water flow, stator pressure drop (top), and slot temperatures (bottom) during the on-line cleaning.

Figure 5 shows the improvement in stator water flow and in the slot temperatures. Stator water flow improved substantially, from $25 \text{ kg} \cdot \text{s}^{-1}$ to $35 \text{ kg} \cdot \text{s}^{-1}$ within 4 days of cleaning. The rise in temperatures before the begin of the cleaning is clearly seen, indicating a quick rise towards overheat within a few weeks. On-line cleaning brought temperatures back to normal within a few days.

It is interesting to note that the hottest slot cooled much faster than the rest. It seems that this bar did not require much oxide to plug it up, in other words it may be especially sensitive to clogging and may be at special risk of plugging again. Such behavior is indicated, for example, if a bar has mechanical flow restrictions, e.g., due to pinched or dented hollow conductors. For long-term stabilization, such bars may need a repair other than chemical cleaning, or a replacement.

The temperature decrease at 205 hours run time was caused by changes in hydrogen cooling and is not related to the cleaning.

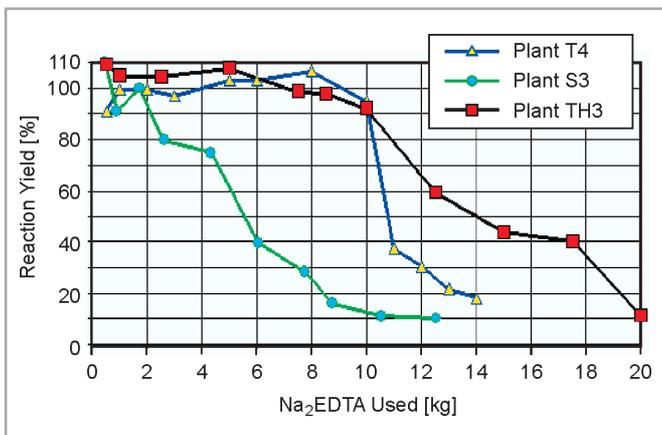
Figure 6: Cuproplex off-line cleaning. Process reaction yield in three different generators. Generator S3 had serious plugging problems; T4 and TH3 were preventive cleanings.

Figure 6 shows process control data for off-line cleanings at generators in a hydroelectric (T4) and two coal-fired power plants (S3, TH3). It is interesting to note that the generator with the least copper oxides had serious plugging problems, while the one with the most oxides was cleaned only as a preventive measure.

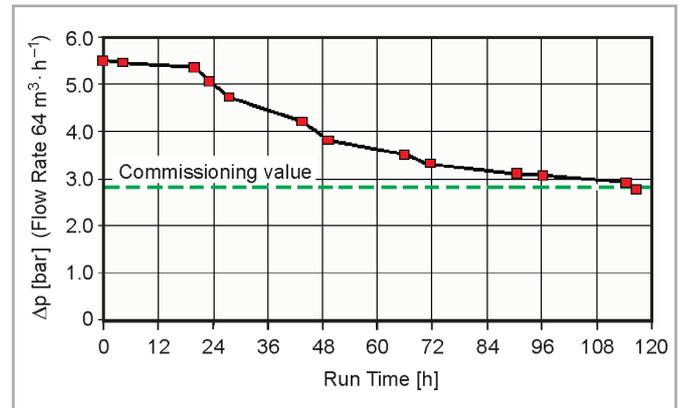
Figure 7: Improvement in stator pressure drop with off-line Cuproplex cleaning (plant GF).

Figure 7 shows the improvement in the stator pressure drop at a 400 MW generator in a gas-fired power plant with off-line cleaning.

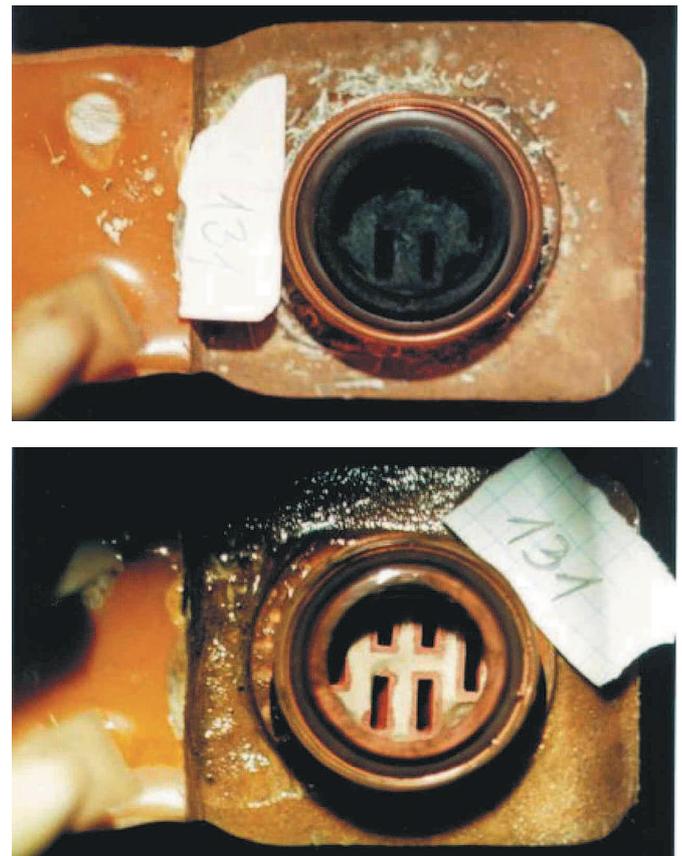
Figure 8: Plant I14: Removal of deposits by chemical cleaning. Condition of the inlet water chambers of the same stator bar before (top) and after (bottom) Cuproplex cleaning. Before cleaning, the surface was covered by black copper-oxide deposits. After cleaning, the clean copper and brazing surfaces are visible.

Figure 8 shows photos of the same water chamber of a 750 MW hydroelectric generator before and after off-line cleaning. The cleaning effect is evident.
