Chemical Cleaning of Water-Cooled Generators: Effect on System Materials

Thomas Bauer, Matthias Svoboda, Sindy Dockheer, and Robert Svoboda

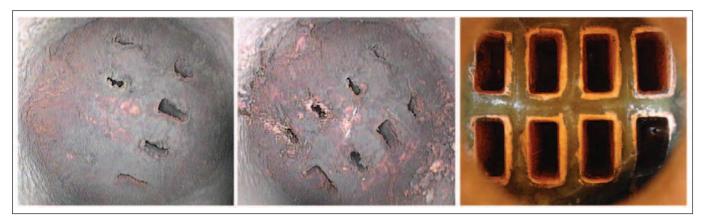
Figure 1: Water box before (left) and after (middle) mechanical cleaning; right: after subsequent chelant cleaning. Note that all pictures were taken of the same water box (T57).

As an option to postpone or even avoid a rewind due to plugged hollow conductors, various cleaning methods are applied [2,5,6]. Chemical cleaning employs either acids or chelating agents (Figure 1).

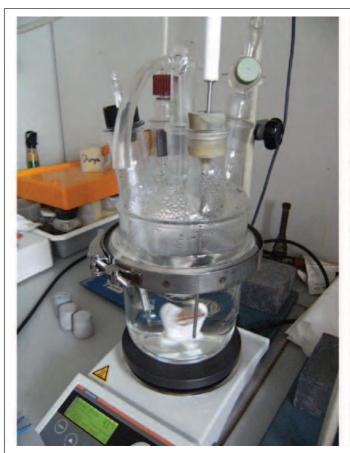
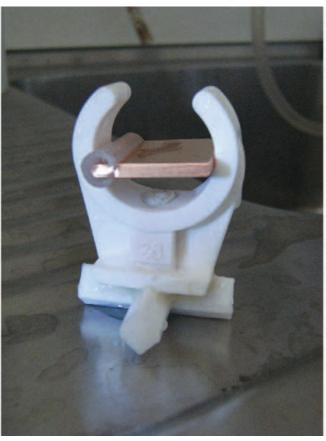
Figure 2: Left: Test setup – the sample is rotated in a sample holder. N_2 was bubbled through the solution via the central connection of the lid. Right: Sample holder.

All samples were prepared and analyzed as follows: samples were cleaned with H_2O (conductivity below 0.1 μ S·cm⁻¹), an organic solvent (either ethanol or acetone) and again with H_2O . The sample was then placed into the sample holder (Figure 2, right) and rotated at 200 rpm in the corresponding solution with given parameters (Figure 2, left; Table 1). Afterwards, the sample was removed, washed again as before testing, and analyzed accordingly.

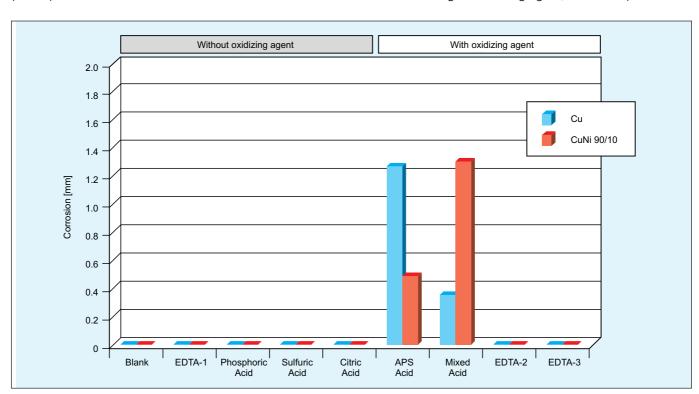
Figure 3: Calculated corrosion in mm of copper and cooler material in different chemical cleaning agents without/with oxidizer.

Significant corrosion and weight losses were observed for the copper and CuNi 90/10 samples in the two acid solutions containing an oxidizing agent, APS Acid (ammonium

persulfate) and Mixed Acid (Figure 3). While in the latter solution, the corrosion measured for the copper sample was 0.48 mm and for CuNi 90/10 1.26 mm (6 and 20 % weight loss, respectively), an opposite corrosion behavior was observed in the APS solution: 1.30 mm for the copper (20 % weight loss) and 0.48 mm (8 % weight loss) for CuNi 90/10.

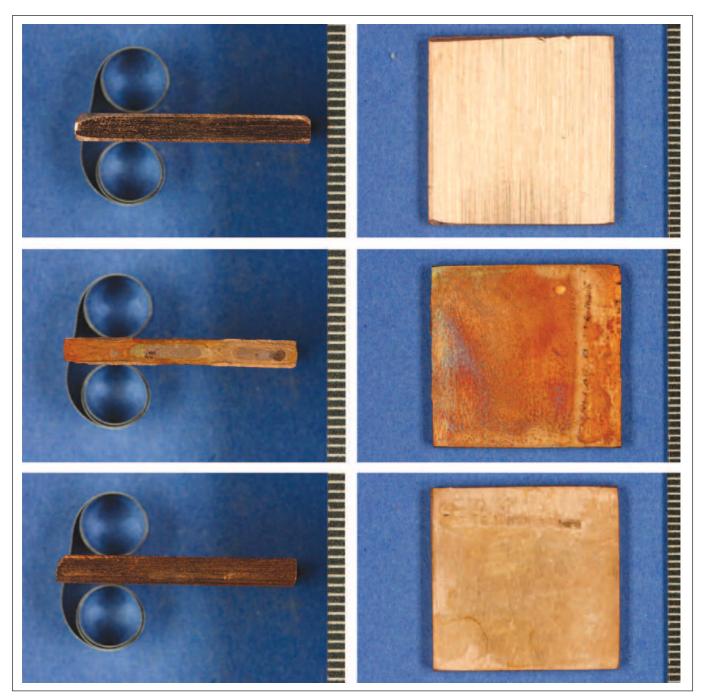
Figure 4: Visual inspection of copper plates. Representative samples from top: EDTA-2, Mixed Acid and APS Acid.

Visual inspections (<u>Figure 4</u>) of the copper plates confirmed the weight loss and color change of the solution and indicated harsh attack by Mixed Acid as well as APS

Acid. Additionally, also the surfaces of the Phosphorus and Sulfuric Acid samples showed significant visual changes compared to the blank solution.

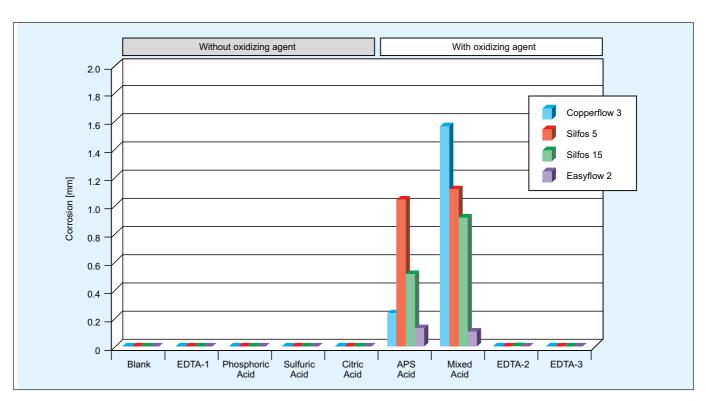
Figure 5: Calculated corrosion in mm of brazes (Copperflow 3 and Silfos 5) and solders (Silfos 15 and Easyflow 2) in 9 different chemical solutions without/with oxidizer.

All analyzed brazes and solders were heavily attacked by both APS and Mixed Acid, the latter dissolving more than 90 % of Silfos 15. If an oxidizing agent (H_2O_2) is added to an EDTA solution (EDTA-2), the "raw" braze can also be slightly attacked (<u>Figure 5</u>, EDTA-2, Silfos 15). This is in disagreement with the analysis of the brazed samples (see <u>Figure 6</u>), where no degradation was observed. The Ontario Power investigation did not observe any attack on braze or solder material. They investigated EDTA/ H_2O_2 and an inhibitor, which delays the reaction kinetics of H_2O_2 [9].

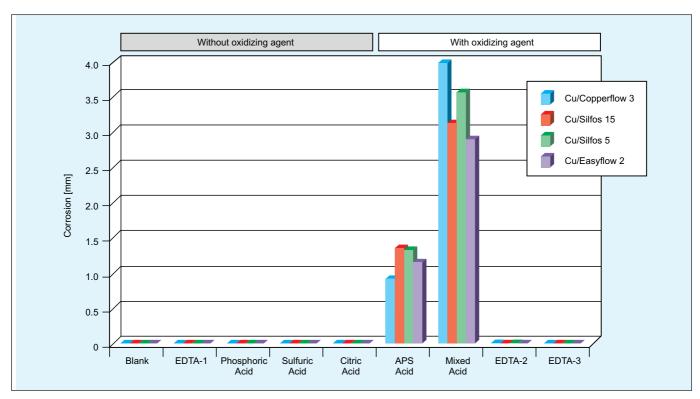
Figure 6: Calculated corrosion in mm of brazed and soldered, sandwich-type samples Cu/Copperflow 3, Cu/Silfos 5, Cu/Silfos 15 and Cu/Easyflow 2 in different chemical solutions without/with oxidizer.

The weight loss of the brazed and soldered samples was comparable with the analysis of the copper and bare brazes and solders. APS and Mixed Acid heavily attacked all samples (> 5 % weight loss). The corrosion for APS was 0.92–1.35 mm for the brazed and soldered samples and about three times higher for Mixed Acid samples (2.89–3.97 mm). This is also in agreement with visual inspection.

No changes were observed for the chelating agent based methods EDTA-2 and EDTA-3 with oxidizer as well as for the acid solutions without oxidizer.

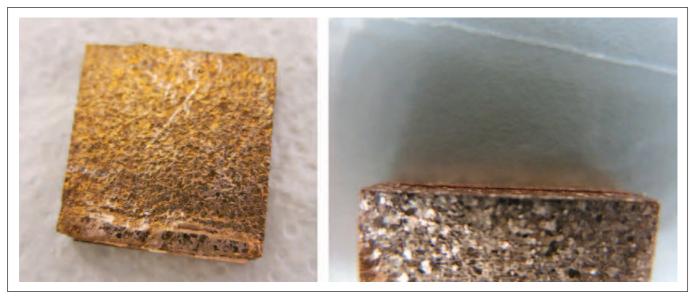
Figure 7:

Representative visual inspection of brazed and soldered copper samples (Cu/Copperflow 3 – left: Mixed Acid; right: APS) including an oxidizing agent in the solution.

Visual inspection (Figure 7) confirmed the results from the corrosion analysis. Both copper and braze were heavily attacked by the acid with oxidizing agent.

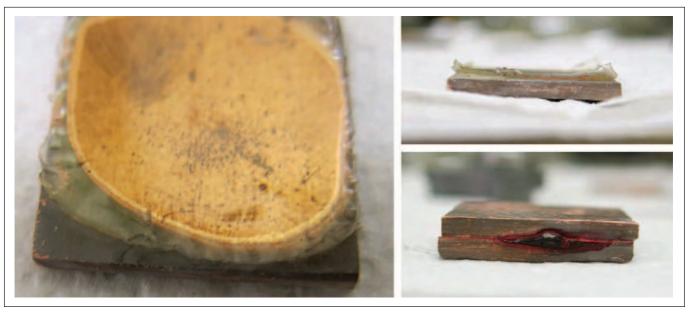
Figure 8: Visual inspection of Cu-Epoxy 1 (left, right top) and Cu-Loctite (right bottom) samples in Mixed Acid solutions.

rial was the Mixed Acid followed by APS Acid. Acid-based cleanings with an oxidizer partly separated the epoxy from the copper surface (Figure 8). For the Cu-Loctite samples,

both copper and Loctite were attacked and dissolved by acid-based cleanings with oxidizing agent. This was not observed for the EDTA-based cleanings, even if an oxidizing agent was present (EDTA-2, EDTA-3).

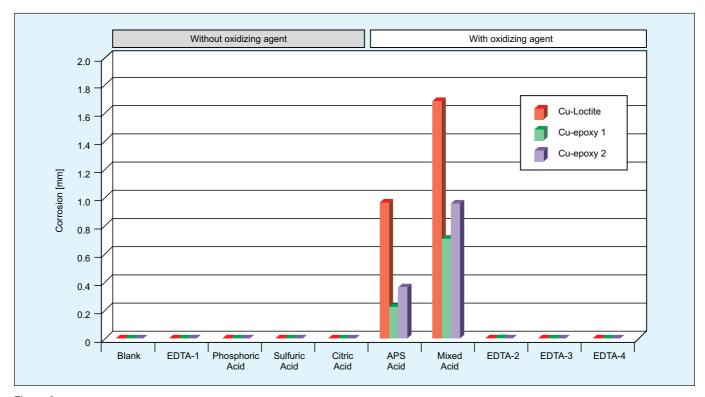
Figure 9:

Calculated corrosion in mm of Cu-Loctite, and two different Cu-epoxy glued samples in different chemical solutions. An additional EDTA-based process (EDTA-4) was also analyzed and validated for the epoxy resins and the Loctite samples without/with oxidizer.

A long-term, EDTA-based process (EDTA-4) was already validated by the Ontario Power investigation [9]. To extend their observations, epoxy- and Loctite-based samples were analyzed regarding their corrosion parameters. No weight loss or any visual changes were observed for the epoxy and the Loctite samples (see Figure 9).
