Corrosion and Deposits in Water-Cooled Generator Stator Windings: Part 4: Operating Experience with Flow Restrictions in Stator Cooling Water Systems

Matthias Svoboda and Thomas Bauer

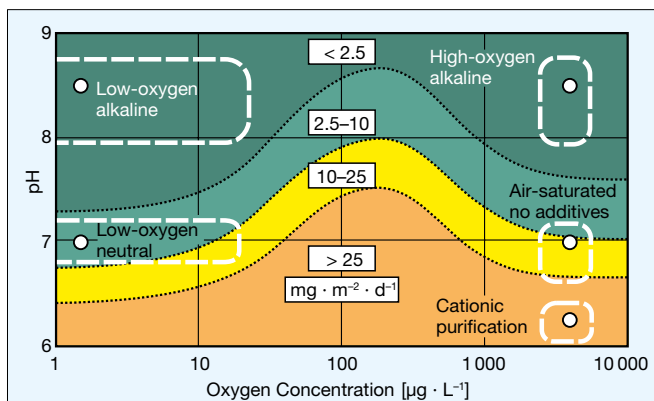
tions until all the oxygen is used up. Such concentrations result in increased copper release rates (Figure 2) [2].

Figure 2: Summary of copper release rate as a function of oxygen concentration and pH; operating areas of the different water chemistry regimes (temperature 45 °C, flow velocity 2 m · s⁻¹ [2].

The high-oxygen design SCWS at plant SB was run at low-oxygen conditions for 14 years because its constant load operation did not permit sufficient gas exchange with the atmosphere through the expansion tank vent. However, during a refuel outage, the system was exposed to air and went through intermediate dissolved oxygen concentrations. This transient zone is characterized by increased copper release rates and can lead to rapid plugging (Figure 2) [2].

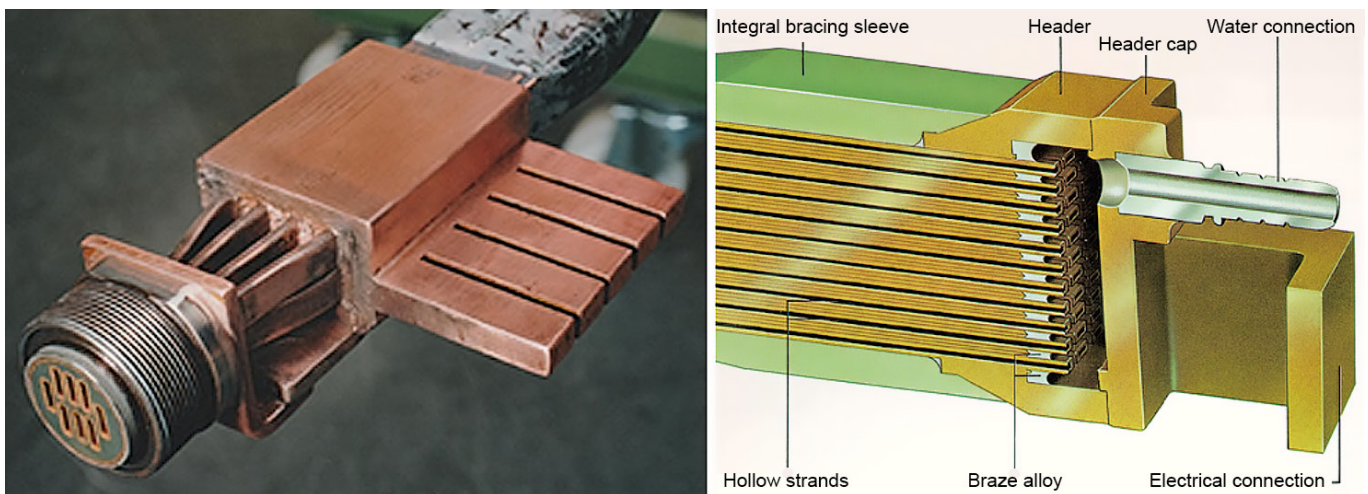
on the water box design, mechanical cleaning may require unbrazing the water box itself (Figure 10). Sometimes, a targeted chemical cleaning on individual bars alone can be successful.

Figure 10: Different designs of stator bar water boxes. The design on the left allows relatively easy access to the hollow conductor inlets, while the design on the right poses greater difficulty to reach all openings [1,9].
